**Flood Control Project Maintenance
Levee Inspections**
LMA District Cover Sheet
Spring 2017 Levee Inspection Results

California Department of Fish and Game Shea Levee

Levee Inspection Report By Mile - Spring 2017

Waterway	Bank	Unit Miles	Inspection Start/End	Inspector
Unit No. 01 Sacramento River	Left	0.30	04/17/2017 04/17/2017	Bob Duffey

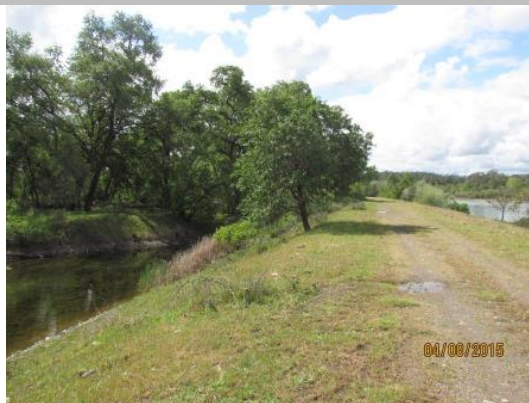
Photo 1 of 2 : SP_2017_NA0018_269_2_20170315_00002.jpg

LM Start	0.00	Rating **	M	Issue No.	2
LM End	0.07	Issue Type +	Ma	Location *	LS
Category	Earthen Levee			GPS Latitude/Longitude	
				Start	End
Item	Vegetation			40.508138 °	40.508138 °
				-122.363480 °	-122.363480 °
DWR ID	DWR_NA0018_01_s_2012_2				
Comment Code					
V2 : Remove the wild growth other than native grasses from the levee slopes.					
Inspector Comment					
California Department of Fish and Wildlife has not completed any maintenance this year.

View of the levee with no maintenance done.

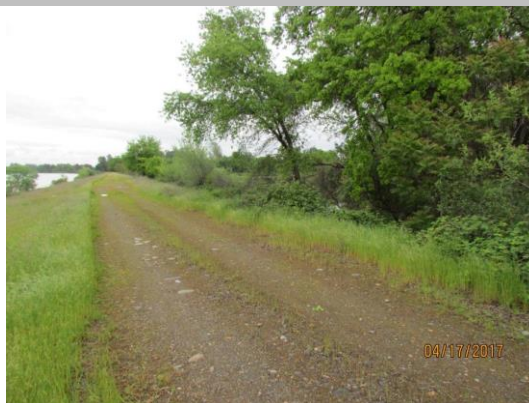
Photo 2 of 2 : SP_2017_NA0018_269_2_20170418_00006.jpg

View of the vegetation along the landside slope.

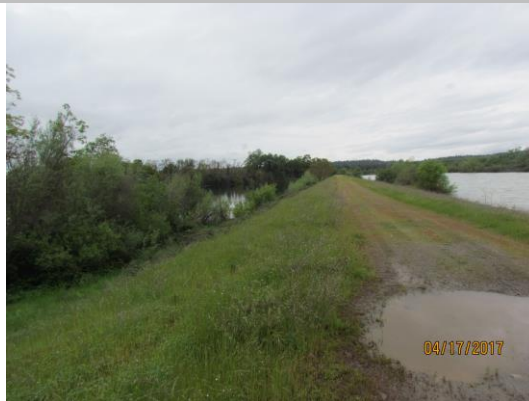
Photo 1 of 2 : SP_2017_NA0018_269_1_20170418_00007.jpg

View of the vegetation along the landside slope.

LM Start	0.10	Rating **	M	Issue No.	1
LM End	0.30	Issue Type +	Ma	Location *	LS
Category	Earthen Levee			GPS Latitude/Longitude	
				Start	End
Item	Vegetation			40.511185 °	40.510670 °
				-122.360553 °	-122.361203 °
DWR ID	DWR_NA0018_01_s_2012_1				
Comment Code					
V2 : Remove the wild growth other than native grasses from the levee slopes.					
Inspector Comment					
Remove the vegetation from the landside slope.

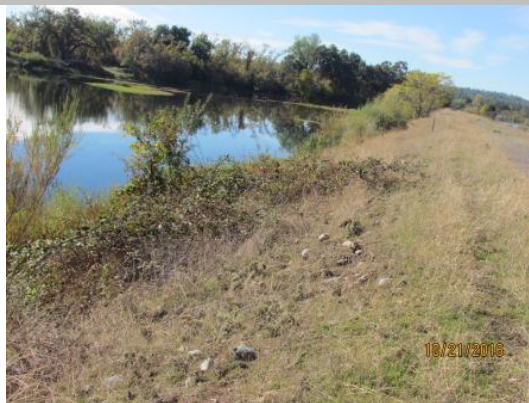
Photo 2 of 2 : SP_2017_NA0018_269_1_20170315_00001.jpg

View of the blackberries and other vegetation along the landside slope.

LM Start	0.10	Rating **	M	Issue No.	1 (cont)	
LM End	0.30	Issue Type +	Ma	Location *	LS	
Category	Earthen Levee			GPS Latitude/Longitude		
				Start		End
Item	Vegetation			40.511185 °		40.510670 °
				-122.360553 °		-122.361203 °
DWR ID	DWR_NA0018_01_s _ 2012_1					
Comment Code						
V2 : Remove the wild growth other than native grasses from the levee slopes.						
Inspector Comment						
Remove the vegetation from the landside slope.

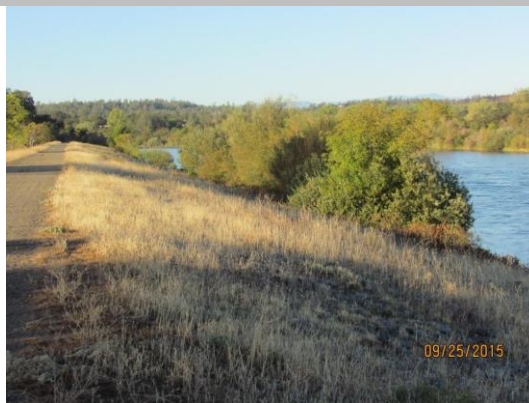
Photo 1 of 2 : SP_2017_NA0018_269_4_20170315_00005.jpg

Trim the trees along the waterside slope.

LM Start	0.21	Rating **	M	Issue No.	4
LM End	0.26	Issue Type +	Ma	Location *	LS
Category	Earthen Levee			GPS Latitude/Longitude	
				Start	End
Item	Trim / Thin Trees			40.511518 °	40.508234 °
				-122.360100 °	-122.363430 °
DWR ID	DWR_NA0018_01_s _ 2012_4				
Comment Code					
T3 : Trim and thin trees to allow visibility of the ground and room to flood fight.					
Inspector Comment					
Trim the trees on the landside and waterside slope

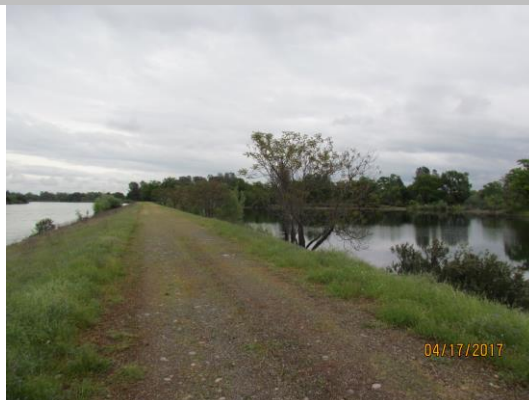
Photo 2 of 2 : SP_2017_NA0018_269_4_20170418_00008.jpg

Trim the trees along the landside and waterside slope.
